# ***Investigating Tile Failures on Wood-Frame Floor Systems<sup>1</sup>***

Frank Woeste and Peter Nielsen

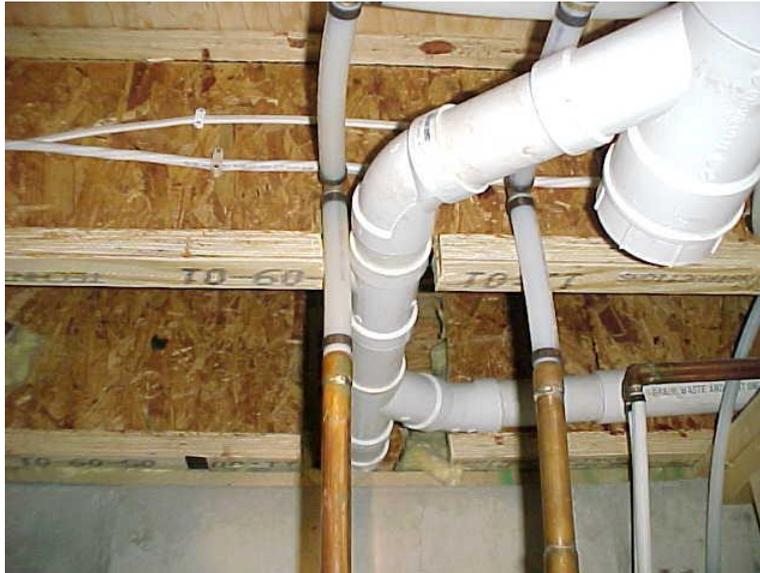
Figure 1. The I-joist depicted has no recognized load capacity because the bottom flange has been cut. The practice of cutting I-joist may stem from the fact that a 2x10, for example, may be notched per the code up to 1.54-inches (or  $D/6$ ) in the outer thirds of the span (IRC, Figure R502.8). Since a typical depth of I-joist flanges is 1-3/8 inches, using the maximum permitted “notching rule” for a solid-sawn 2x10 on an I-joist destroys the strength and stiffness capabilities of the joist.

It may be obvious that the cut bottom flanges are detrimental to the strength and stiffness of the joist shown in Figure 1, but the impact of the cut joist on the ability of subfloor sheathing to support a brittle floor surface may not be obvious or well understood. The cut joist, which is approximately 17" from the concrete wall, causes the effective spacing of the joists supporting the subfloor to be 32", well in excess of the 16" permitted joist spacing for method F144-07. Note that a second joist flange in Figure 1 is also cut. However, because it had a slight amount of bearing on a sill plate, we did not include in our analysis the possible impact of the cut flange on subfloor span.

The detrimental impact of the longer 32" subfloor span on the tile and grout in the affected area is severe and probably not intuitive. We studied the case where a section of floor sheathing, Case A, is supported by three code-conforming joists at 16" on-center (oc). A load of 200 lbs. represents foot traffic, appliance, dolly, or other live load. To simulate an I-joist with a cut flange, we removed the center joist in Case A resulting in Case B, a single span<sup>2</sup> with joist supports at 32" oc. We moved the 200-lb. load to the center of the single span as depicted in the figure for Case B.

Assuming the identical subfloor and tile method are supported by the joists depicted in the Case A and B drawings, the maximum deflection of the Case B subfloor/tile assembly was 11-times greater than the maximum deflection for Case A. If a specific load on the 16" span (Case A) produces a deflection of 0.01-inch, we would expect the same load to produce a maximum subfloor/tile assembly deflection of  $11 \times 0.01$ ", or 0.11" for Case B<sup>3</sup>. However, for appreciating the role of subfloor span on hard-surface flooring performance, a simple rule-of-thumb would be that maximum sheathing deflection between joists is related to the *cube* of the support spacing—that is, increasing the span by a factor of two produces eight times more deflection ( $2^3=8$ ).

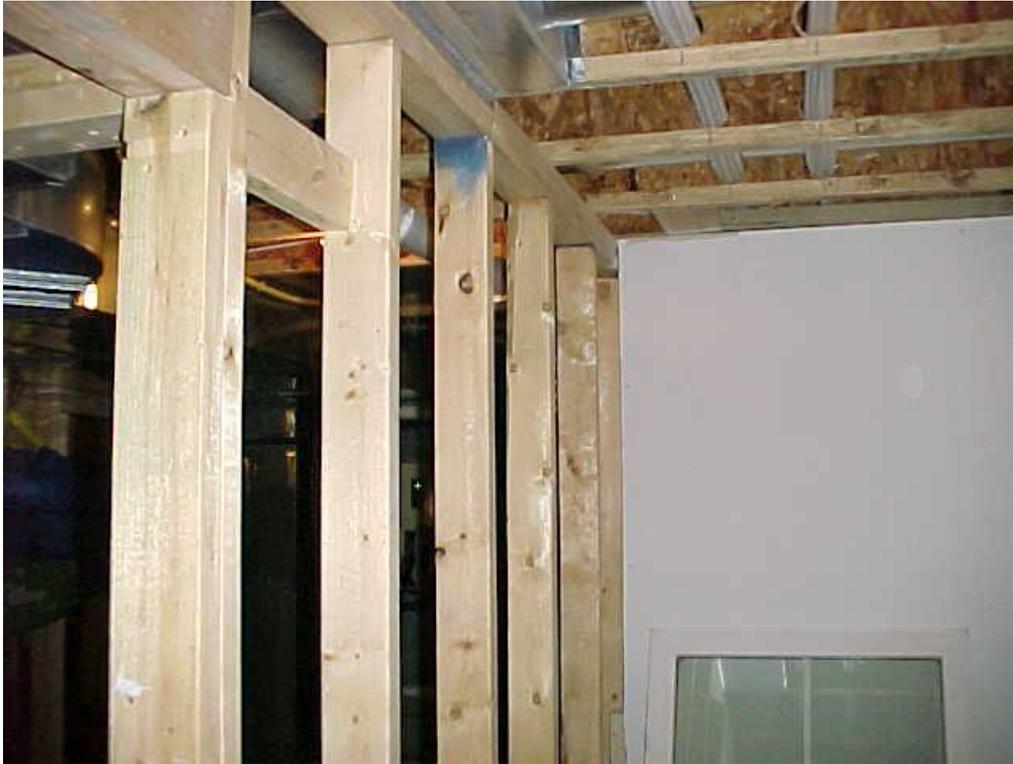
Figure 2. Load-bearing wall without sheathing used to support the I-joist framing.

case, the homeowner elected to go with an unfinished basement, the tile was installed, and in-service grout cracks prompted an investigation. Unfortunately, the design load capacity for the “load-bearing wall” depicted in Figure 2 is *theoretically* zero because the studs are not braced by drywall, wood paneling, or wood sheathing on at least one side of the wall. Of course the wall has some capacity, but it has no *recognized* capacity according to the *National Design Specification for Wood Construction* (NDS, 2005) because the slenderness ratio is greater than 50. The slenderness ratio is defined as the length of the stud or column divided by the thickness of the stud (in this unbraced case). For the wall shown, the slenderness ratio is  $92\text{-}5/8''/1.5''$ , or about 62. Unbraced studs having a slenderness ratio greater than 50 cannot be relied on to support in-service loads as the individual studs are free to “buckle” about their “weak axis.” When drywall or sheathing is applied to the studs, the slenderness is about 26 and the stud has substantial load capacity and provides a very stiff reaction support for the joist.<sup>4</sup> As constructed, the bearing wall is very flexible when loaded by the first floor occupants (or

other live loads) and would be expected to produce tile and grout damage in some areas that are structurally related or supported by the stud wall that was *intended* to be a load-bearing wall.

Drywall or sheathing is typically used to laterally brace studs in load-bearing walls. The nails attaching the drywall or sheathing to the studs provide the needed lateral restraint for the studs. When an interior load-bearing stud wall is properly designed to support the applicable dead and live loads and the studs are laterally braced as assumed by the designer, the stud wall provides a stiff (and safe) bearing support for the floor joists.

The need for bracing load-bearing basement walls is not well understood by all parties involved in wood-frame construction. Careful study of the IRC (2006) will reveal that interior load-bearing walls must be braced by sheathing or other means as is specified for exterior walls (See IRC, Sections R602.4, R602.3, and Figure R602.3(2)).
